CITY OF EAST GRAND RAPIDS

Traffic Control Order #53

Re: School Pedestrian Crossings Review
Six East Grand Rapids Schools

Progressive AE has completed the review of the applicable school crossings adjacent to six schools within East Grand Rapids. The following sections summarize our findings and recommendations regarding potential upgrades or revisions to the current crosswalk controls.

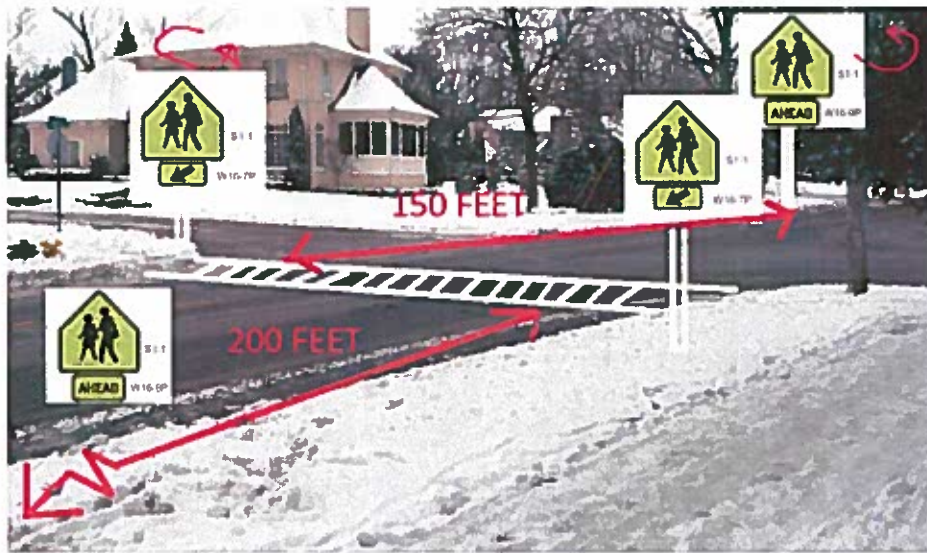
The East Grand Rapids Department of Public Works to place four school crossing signs with posts on Lake Drive. Place two of these school crossing signs with arrow plaques at the crosswalk, one eastbound and one westbound. Place the other two school crossing signs with AHEAD plaques, one for eastbound located 150 feet west of crosswalk and one westbound located 200 feet east of crosswalk.

The Engineering Department will be responsible for making arrangements to have the continental crosswalk pavement markings placed at the crosswalk, east of the intersection crossing Lake Drive.

4 signs - 11.00 - 12/13 - MD

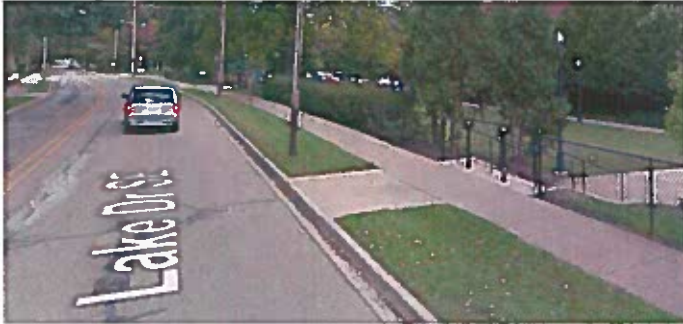
The East Grand Rapids Department of Public Works removed a section of sidewalk on October 26, 2018, and restored. No further action needed.

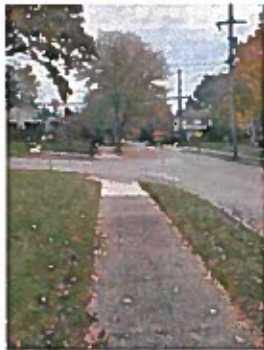
The East Grand Rapids Department of Public Works to remove the pedestrian crossing sign and post. Then place a school crossing sign with arrow at a new location at the ramp on Burchard Street. Also, place a new school crossing sign and the AHEAD plaque at a property line 155 feet to the west of the crosswalk.

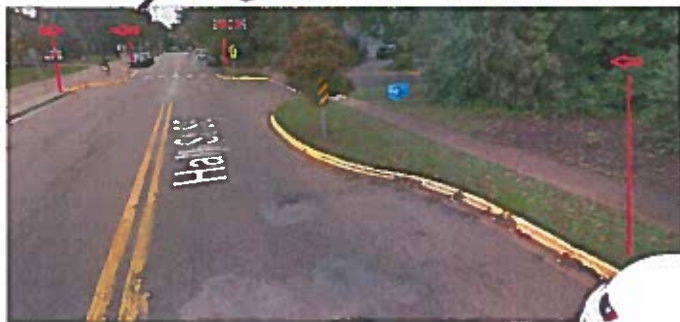
The East Grand Rapids Department of Public Works to place four no stopping/ standing /parking signs at the bump-out locations, as shown above, to increase visibility of pedestrians during winter months when painted curbs can be snow covered. *3 of 4 done*

Needs done - In sidewalk

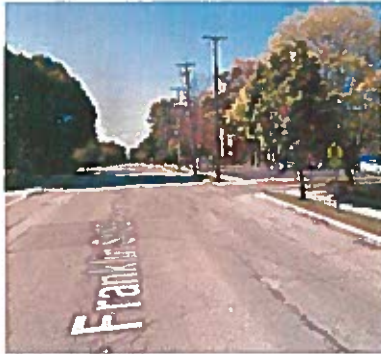
The East Grand Rapids Department of Public Works to relocate the school crossing sign, with the AHEAD plaque, to a new location that is approximately 120 east of the crosswalk.

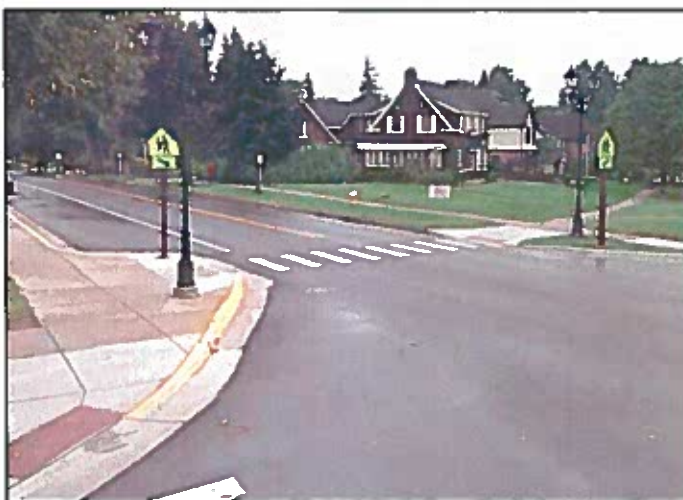
The focus of the pedestrian crossing concerns, both past and present, are on Lake Drive, particularly at the primary Lake Drive crossing located at its intersection with San Lu Rae Drive/Bagley Avenue. Additional pedestrian crossings are located on Lake Drive at Lakeside Drive, Maxwell Avenue, and Ogden Avenue, but are not currently identified specifically as school crossings.

A review was completed last year of the Bagley Avenue/San Lu Rae Drive crossing with subsequent upgrading of crossing pavement markings and signs, so this primary crossing is already up to date. Its current bump-out narrowing and crosswalk markings closely align with guidelines of both the MMUTCD and NACTO source documents, and in particular, pages 112 and 113 of the NACTO book.

However, pedestrian crossing counts were completed in May 2018, to further define the level of use of this crossing for school activities. That data indicates that approximately 175 pedestrians, assumed to be mostly students, cross Lake Drive at Bagley Avenue/San Lu Rae Drive during the morning peak hour, with 112 of those occurring during the peak 15 minutes. During the afternoon pedestrian peak hour, approximately 180 students crossed at this intersection, with 125 of those crossings occurring during the peak 15 minutes around 3:00 pm.

Improvement Recommendations: none other than ongoing oversight and maintenance.

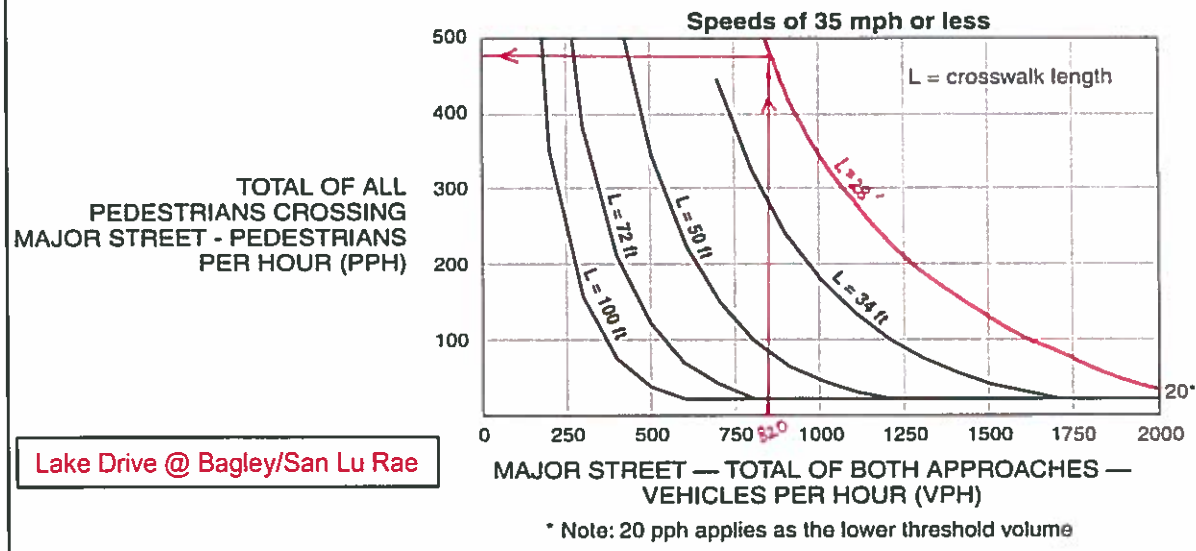
Figure 4F-1. Guidelines for the Installation of Pedestrian Hybrid Beacons on Low-Speed Roadways

Even though those are significant pedestrian crossing volumes, they are not high enough to meet MMUTCD criteria for installation of a type of pedestrian hybrid signal. The applicable statement in Section 4F.01 of the MMUTCD for such locations notes;

"For a major street where the posted or statutory speed limit or the 85th-percentile speed is 35 mph or less, the need for a pedestrian hybrid beacon should be considered if the engineering study finds that the plotted point representing the vehicles per hour on the major street (total of both approaches) and the corresponding total of all pedestrians crossing the major street for 1 hour (any four consecutive 15-minute periods) of an average day falls above the applicable curve in Figure 4F-1 for the length of the crosswalk."

Since the traffic volume on Lake Drive during the same peak hour is approximately 820 vehicles and the crossing width is 28 feet, a marked-up version of Figure 4F-1 on the next page indicates that the total pedestrian crossing volume across Lake Drive at this intersection would need to be over 400 pedestrians to meet the criteria for installing such a signal. Therefore, the combination of the peak pedestrian volumes, Lake Drive traffic volumes, and the crossing distance are easily below the required threshold for installing a pedestrian related signal.

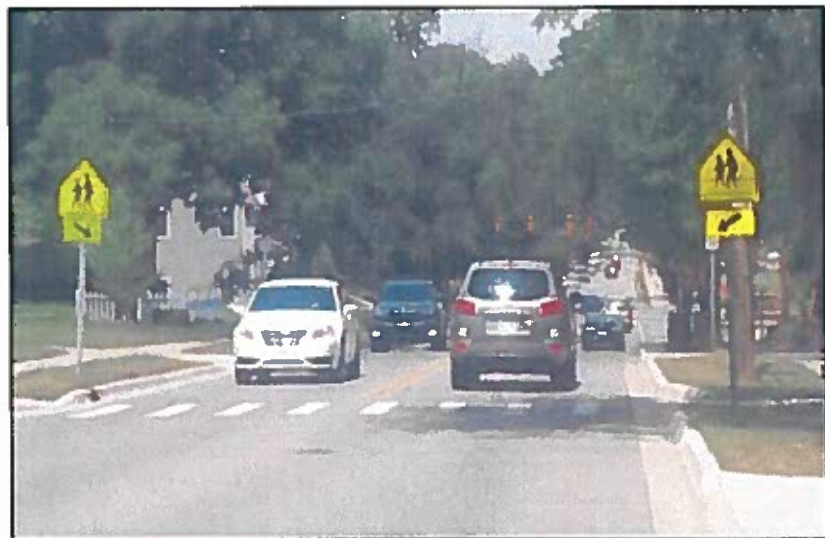
Given those recent improvements, the primary focus at the East Grand Rapids Middle School now is the pedestrian crossing at the intersection of Lake Drive and Kenesaw Drive. This crossing was reviewed in 2017 for potential signal or warning beacon installation; it was found that the combination of pedestrians, traffic volume, and crossing width did not meet criteria for additional controls. Crossing signs were subsequently updated bringing this location in line with current MMUTCD and NACTO guidelines.

New pedestrian crossing counts were taken in May 2018 to re-confirm the applicability of the current controls. Those counts indicated that approximately 85 pedestrians use that crossing during the morning peak hour, and approximately 63 pedestrians cross during the afternoon peak, largely around 3:00 p.m. Combined with the 25 mile-per-hour speed limit, a relatively short crossing distance of about 25 feet, and a traffic volume of about 650 vehicles during that morning pedestrian peak, the data confirms earlier findings that additional signal or flash type controls are not warranted at this crossing.

Improvement Recommendations: none other than ongoing oversight and maintenance.

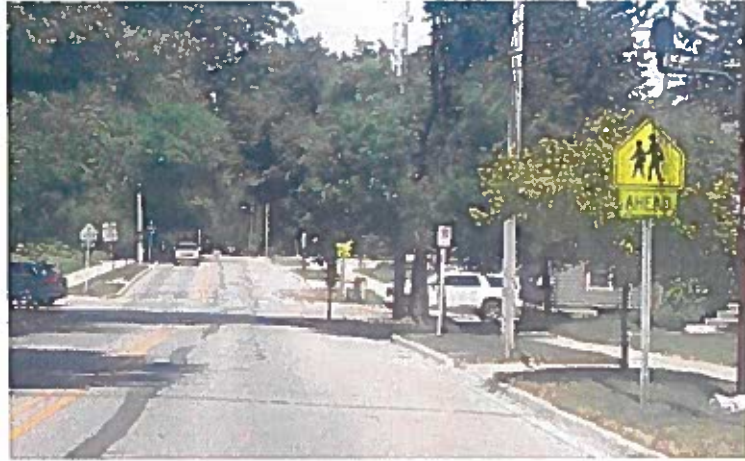
The current key pedestrian crossings for the Wealthy Elementary School are on both Lake Drive and Wealthy Street. The primary/defined school crossing on Lake Drive occurs at its intersection with Lovett Avenue, where recent sign upgrades and location adjustments were completed. NACTO guidelines were followed by narrowing Lake Drive with bump-outs on the north side (reduces pedestrian exposure time) and the use of heavier continental crosswalk markings that better define the crosswalk location. A flashing beacon is in operation during appropriate periods adjacent to the advance warning signs on the westbound Lake Drive approach to Lovett Avenue. Based upon city input, this location is also manned by crossing guards during school peak periods.

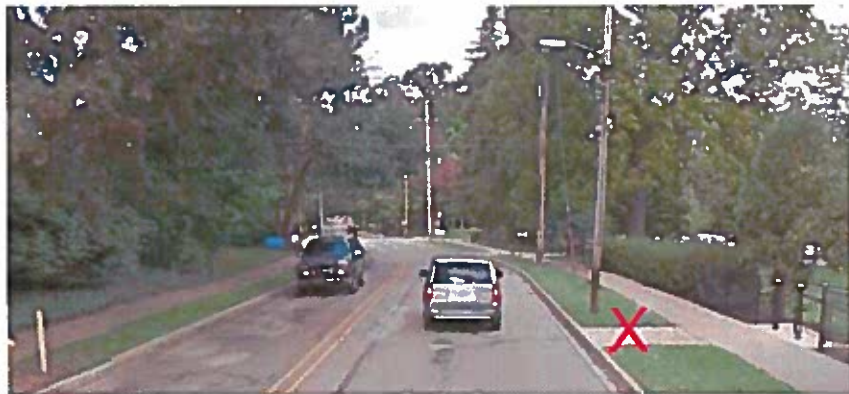
Pedestrian counts were also taken at an unmarked/unsigned location on Lake Drive adjacent to the school. Given an existing sidewalk section that extends to the back of curb, the pedestrian use of this location for crossing Lake Drive may have been in question. In any case, the counts indicate that only one to three pedestrians crossed at this location during the school-related peak periods. Based upon this result, and the fact that there is no north/south street or pathway that leads into Lake Drive at/near this location, there is no sound rationale for creating a defined crosswalk at this location.

Consideration should be given though to removing the small sidewalk section in case it is leading to use as a crossing location.

- Removal of small sidewalk section at Lake Drive mid-block location (see red X on above picture)
- Remove old advance pedestrian sign and beacon at Lake Drive/Locust Avenue or upgrade to current standards
- Ongoing oversight and maintenance.

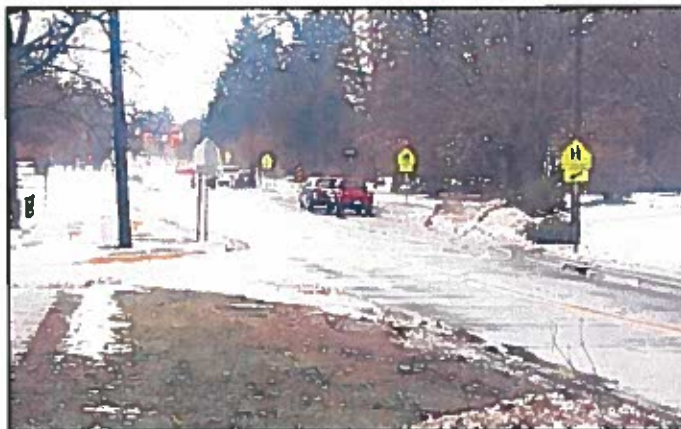
Lakeside Elementary School currently has an extensive set of defined school pedestrian crossings, primarily focused along Hall Street. The primary crossing at the intersection of Breton Avenue and Hall Street is signal controlled with new countdown pedestrian signals and new crosswalk markings completed as part of the Breton Avenue reconstruction. This set of upgrades now provides an environment that further brings it in line with current MMUTCD and NACTO guidelines. For this location and others, we should note that NACTO strongly supports the use of countdown pedestrian signals as their urban design book notes on page 111:

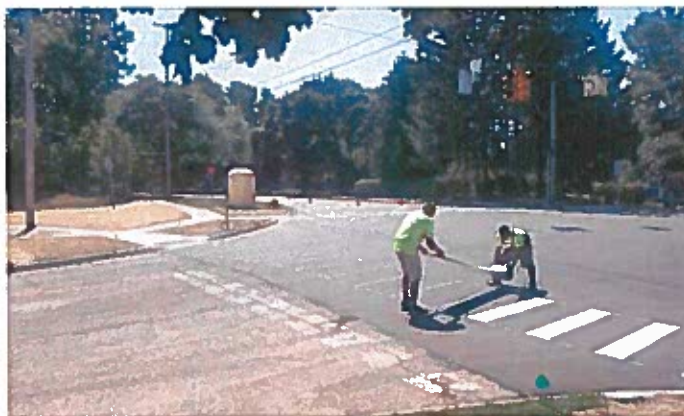
In addition to that signal-controlled intersection, there are two other school-related crossings across Hall Street west of Breton Avenue. Those are at the Hall Street/Anderson Drive and Hall Street/Lakeside Drive intersections. A set of non-school crossing signs are located

at the residential low-speed Lakeside Drive/Burchard Street intersection, just northwest of the school. We should note, there are additional Hall Street crossings further to the west; the location and sign type (along with an eastbound facing flashing beacon) do not appear to be school-related so are not within the purview of this review. Having said that though, it should be noted that the eastbound crossing signs and beacon at the Pincrest intersection should be relocated to a point immediately adjacent to the crosswalk, along with relocation of an adjacent small wood utility pole if it blocks visibility of the relocated beacon.

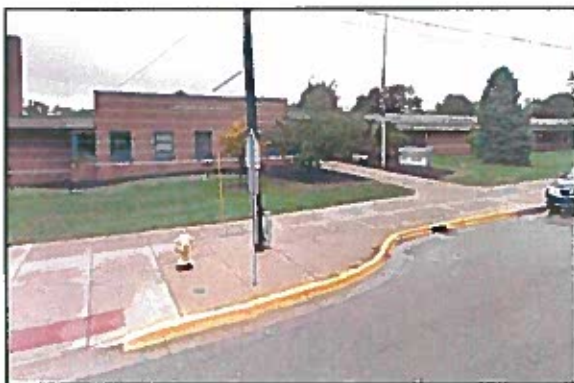
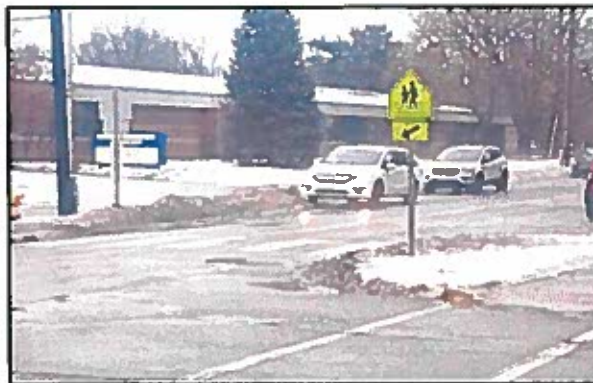
As with most other locations around the East Grand Rapids schools, signs and markings have been brought up to current standards over the last year. Advance warning signs have been brought into conformity regarding the AHEAD plate and distance from the actual crossings, and the signs at the crosswalks now have the current "arrow" advisory plate. Both Hall Street crossings have short exposure/crossing widths due to the sound decision to provide curb bump out sections per NACTO guidelines (page 112) at these locations and are further enhanced by no parallel parking allowed/ provided near the crossings on the approach side of each. The limits of the painted no parking zones, however, can be obscured during winter months as the comparison photos on the next page show.

- Longer term—consider lengthening one or more bump outs to eliminate seasonal pedestrian visibility issues related to hidden painted curbs;
- Review potential for changing the Burchard Street crossing at Lakeside Drive to a school crossing with applicable sign assemblies, or at a minimum, adjust the location of the existing crosswalk signs to a point directly adjacent to the crosswalk, upgrade the crosswalk markings, and paint the westbound approach curb yellow to eliminate potential parallel parking within 30 feet of the near edge of the crosswalk;
- Consider slight relocation of one or more object warning signs on Hall Street.

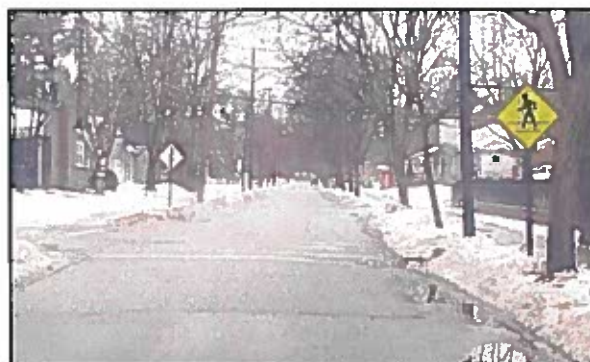
Pavement markings and signs at/near the Lakeside Drive/Burchard Street intersection are currently standard pedestrian crossing signs, not school crossing signs. However, given the proximity to Lakeside Elementary and the apparent crossing pattern (south and east sides of the intersection), the city and school may want to consider replacing, and relocating, the existing signs with school crossing signs.

With or without those sign type revisions, the crosswalk markings should be upgraded to the heavier longitudinal type markings for extra emphasis and recognition by drivers. Parking within 30 feet upstream of the Burchard Street crossing, westbound approach, should be prohibited to provide better pedestrian visibility on that east side. Current crossing signs should also be relocated to points adjacent to the actual cross walk.

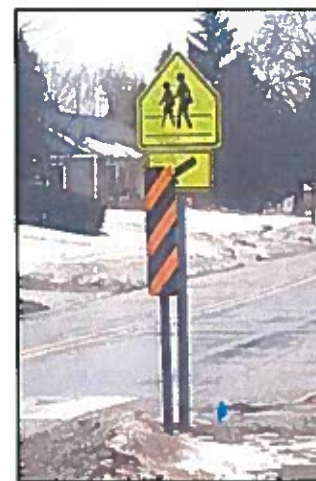
One additional item of note: there are several object marker signs (OM3-R) used along this section of Hall Street, apparently installed to warn drivers of the intermittent curb bump outs. There is at least one that may hinder visibility of the crosswalk signs, and therefore should be considered for a slight relocation.

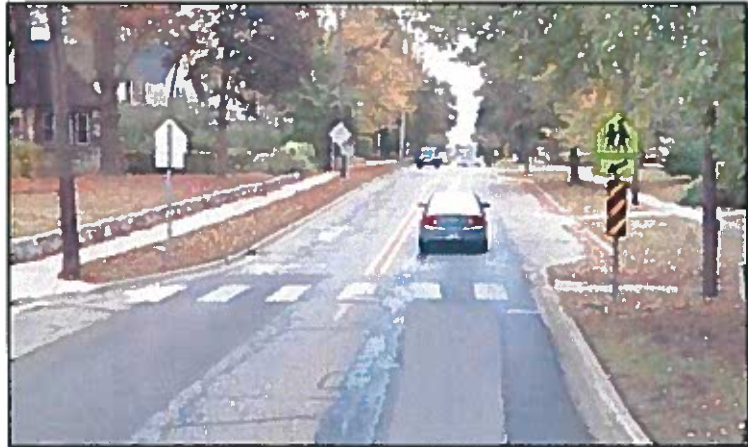
Given the traffic volumes on Breton Avenue, of particular focus in past years has been the school crossing across Breton Avenue at Berwyck Road. There are also two other crosswalk locations adjacent to the school on Boston Street, although neither are designated as school crossings. The eastern of those two locations, at the Boston Street/York Drive-Lake Grove Avenue intersection, has all-way stop sign control that inherently provides a relatively safe pedestrian crossing environment. Crossing guards are currently used at both the Breton Avenue/Boston Street and Boston Street/York Drive intersections.

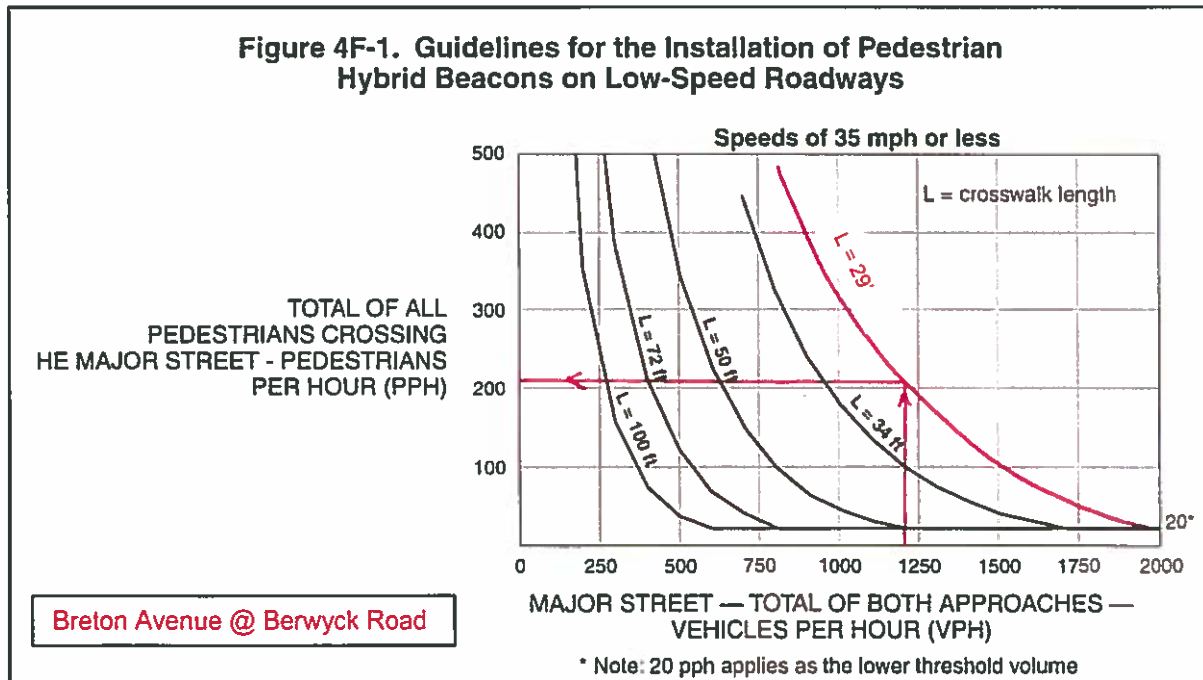
Figure 4F-1. Guidelines for the Installation of Pedestrian Hybrid Beacons on Low-Speed Roadways

As noted for other school locations, the school crossing on Breton Avenue at Berwyck Road was recently upgraded to include newer advance warning signs and applicable signs and advisory plates at the crosswalk itself. Pedestrian counts at this location taken in May 2018 indicate that approximately four pedestrians use the crossing during the morning peak hour and approximately nine students use the crossing during the afternoon school peak. Even with the 1,200+ peak-hour traffic volume on Breton Avenue in this area during the afternoon school peak, the short crossing distance of approximately 29 feet combined with the very low crossing volume does not meet pedestrian thresholds to warrant a signal or warning beacon as shown on the marked-up version of Figure 4F-1 below.

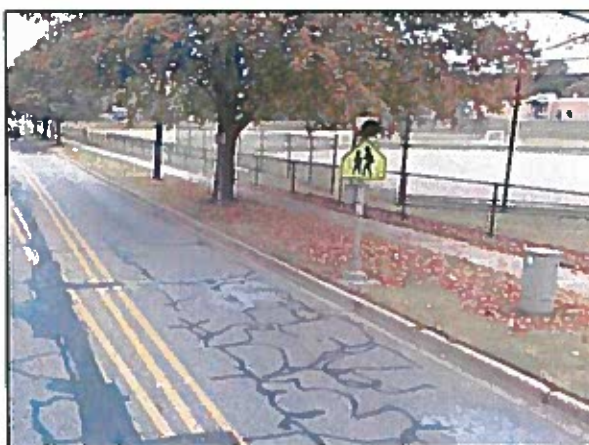
There are two related items of note: currently there is an object warning sign (OM3-R) mounted on the southbound pedestrian crossing sign post as can be seen in the photo on the previous page. Since there is no bump out in this direction and apparently no other adjacent object, it brings in the question the need for the object sign.

There is also an existing advance school crossing sign and a low-mounted beacon on Breton Avenue facing south located just north of Berwyck Road. This doesn't appear to follow current standards either in location or design, although we suspect it was placed there as a general warning to drivers that there are school children in the area.

- Consider removing the object warning sign on the southbound side of Breton Avenue at the crosswalk at Berwyck Road since no obstruction is evident at this location.
- Confirm the rationale and need for existing advance school crossing sign and beacon located on Breton Avenue just north of Berwyck Road; if none, remove.

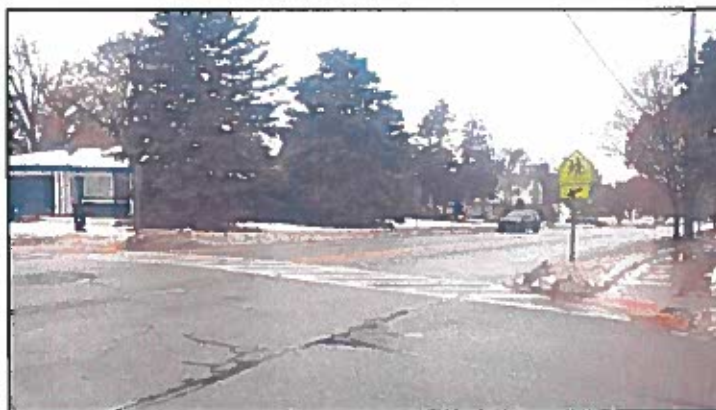
The focus of school related crossings at St. Stephen School is primarily on Franklin Street where the single designated school crossing is located on the west side of its intersection with Gladstone Drive. Along with the public-school-system sites, the school crossing signs along Franklin Street at St. Stephen School were updated within the past year or so and now generally appear to meet current design criteria. Crosswalk pavement markings also appear to be in good condition at that school crossing location. Crossing guards are also utilized at this Franklin Street crossing.

Advance warning sign assembly for the westbound approach is longer than is appropriate for a 25 mile-per-hour speed zone. Even if the 85th percentile speed is slightly higher than 25 mph, the advance assembly should be moved closer to the crosswalk location. Also, the current advance crossing sign location encompasses another lesser defined crosswalk on Franklin Street at its intersection with Rosewood Avenue. This could cause some confusion as to which crosswalk the signs are intended for. The eastbound advance crossing sign assembly is in an acceptable location.

- Shift the location of the westbound advance warning sign assembly to a point approximately 150 to 200 feet or so upstream of the crossing, keeping in mind that typical driver visibility of those signs is considered to be at least 180 to 200 feet upstream of that spacing.
